RTU Firmware Upgrading Instruction

To serve our customer better, Caimore will keep improving the product quality including the hardware, firmware and the software. Here is a instruction for RTU(Remote Terminal Unit) firmware upgrading. Customers are able to upgrade the firmware according to the following steps by themselves.

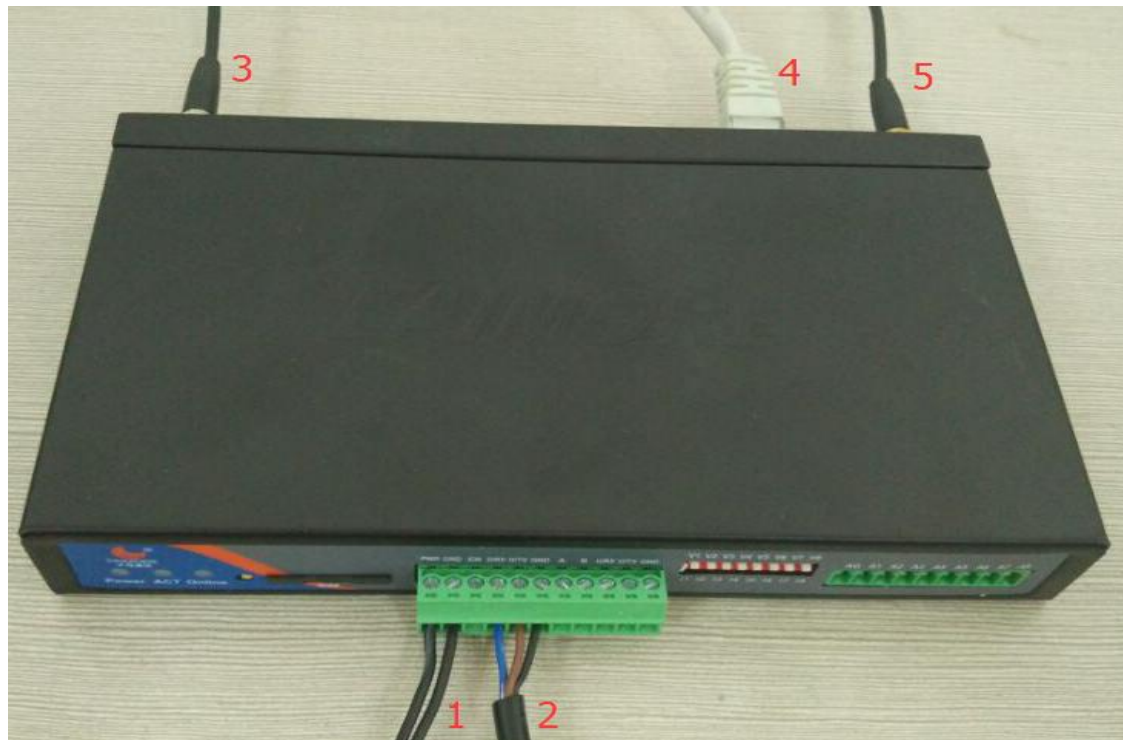
Please connect RTU to PC according to following steps, before upgrading the firmware.

1. Power wire (PWR——black with white, GND——black);
2. RS232(D/RX——blue, D/TX——brown, GND——black): Please use this RS232 serial port to connect PC; USD forwarder to RS232 can be instead of if there is no RS232 serial port on PC.
3. 2G/3G/4G antenna;
4. To connect the cable to PC;
5. ZIGBEE/GPS antenna.

Note: Please ensure that RTU is powered off before you do above operations!

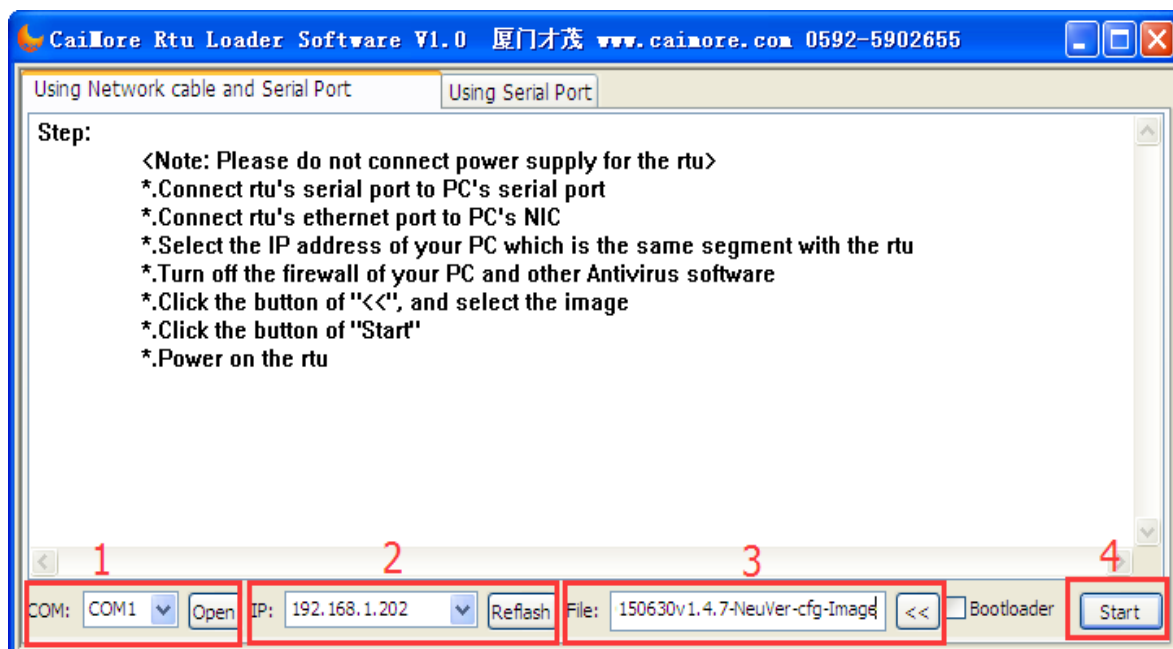
Please open the file name as "Caimore-Rtu-Loader.exe" (Icon is

1. Select COM: The default COM1 refers to the port connection from RS232 serial port to PC; If USB to RS232 be used, the relative COM number can be checked like this: right click "My Computer" -----> "device management" -----> "interface (COM & LPT)".
2. PC's IP address: When the RTU direct connect with the PC, the IP is not same as PC's. Please click "Reflash" to capture PC's IP. Then power off the RTU. If the RTU connect with PC via router, Its IP address is same as PC's already.
3. Select file: To choose the "Image" file to upgrade.
4. Start: Click "Start" to start upgrading.

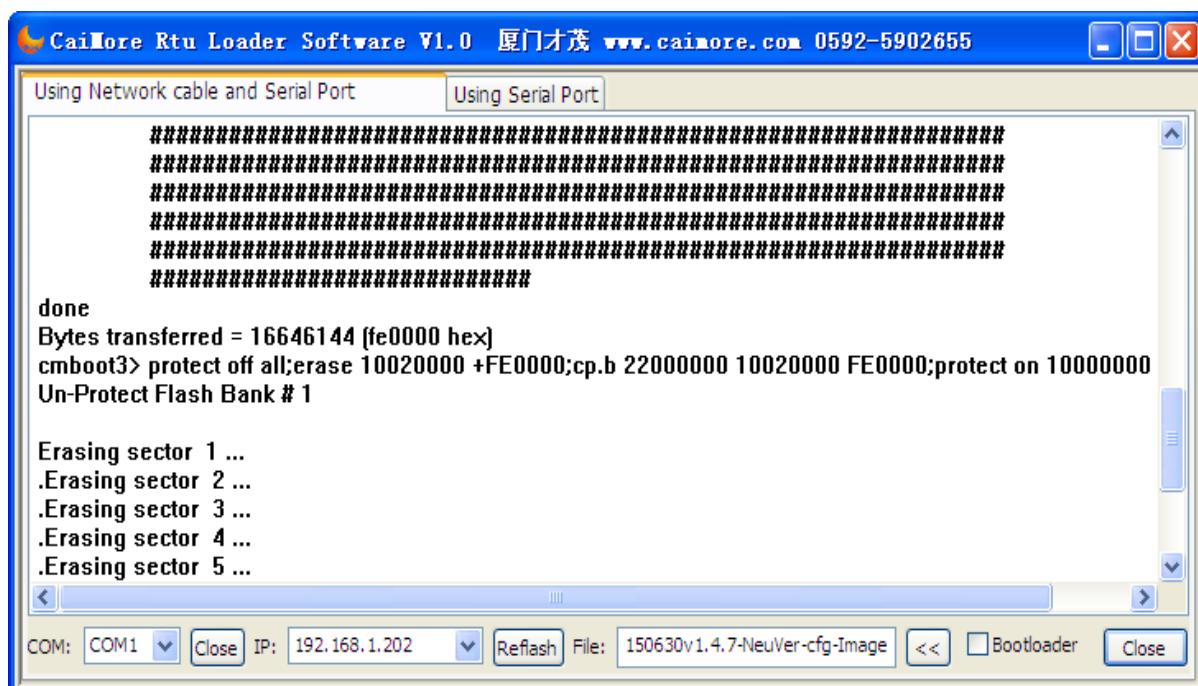
3) RTU firmware upgrading

Please power on the RTU to begin upgrade, see as below picture:

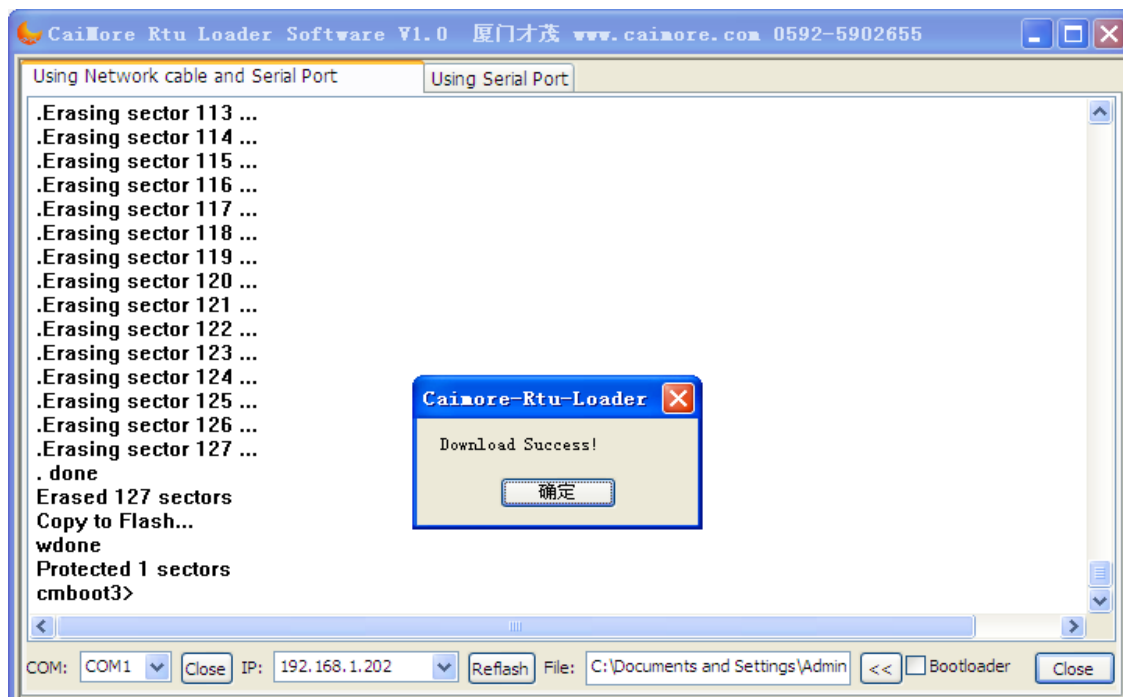
4) RTU firmware upgrade finished

About 2 minutes later, the upgrading will be finished once there is pop-up window with "Download Success!". Then you can close this loader software and power off the RTU.

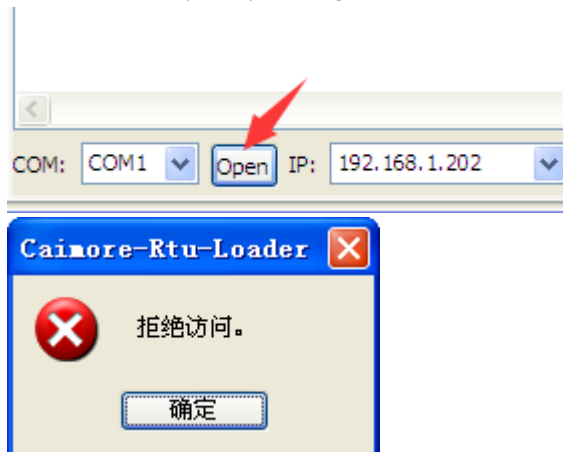
1. Failed to open "COM"

The COM is occupied by the other software program if there is a pop-up window with "Access Denied" when you click "Open". In this case, please close the COM on the other software first, and try to open it again.
